# INSPECTION REPORT SAMPLE

**FOR THE PROPERTY AT:**

123 anywhere street

March 27, 2022

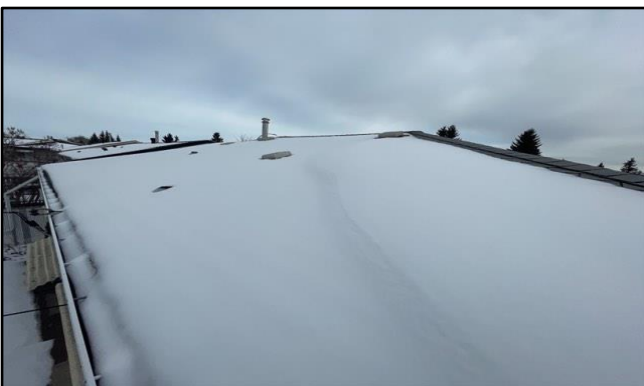
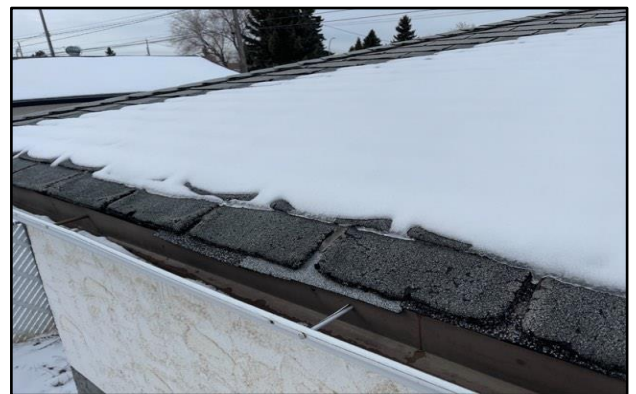
**Inspection limited/prevented by**

Snow

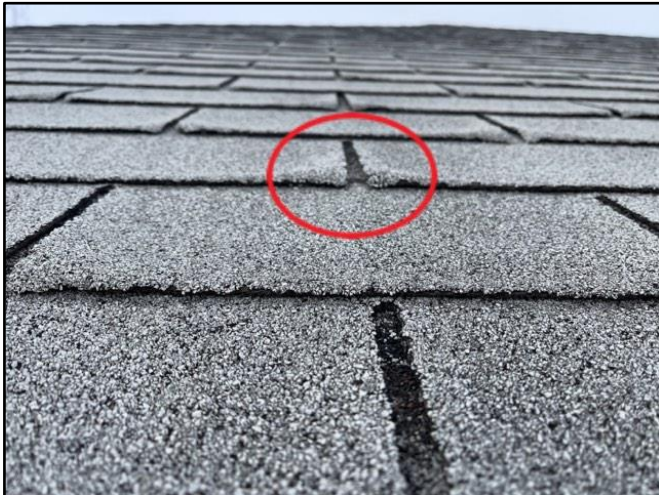
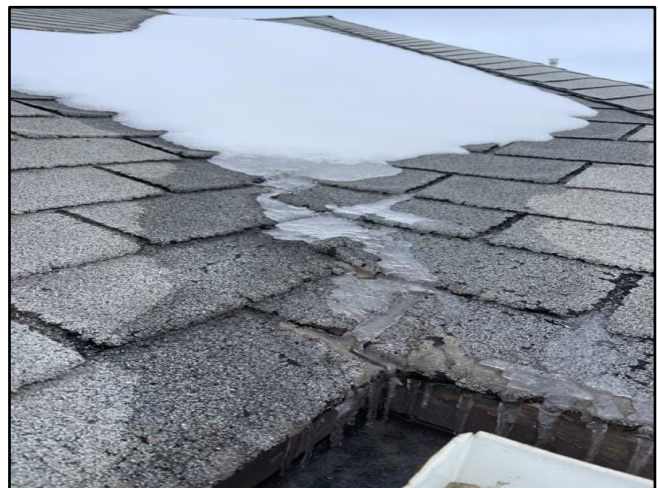
Aging

**Notes:** Roof shingles where visible are showing signs of curling and signs of deterioration in the valleys. Recommend monitoring and further evaluation by a roofing specialist when snow has been removed or melted.

**Task:** Monitor

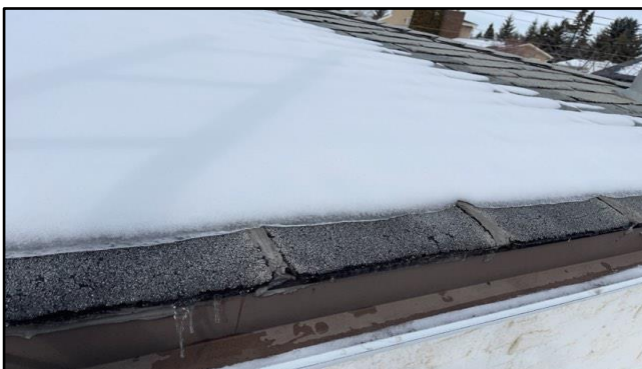
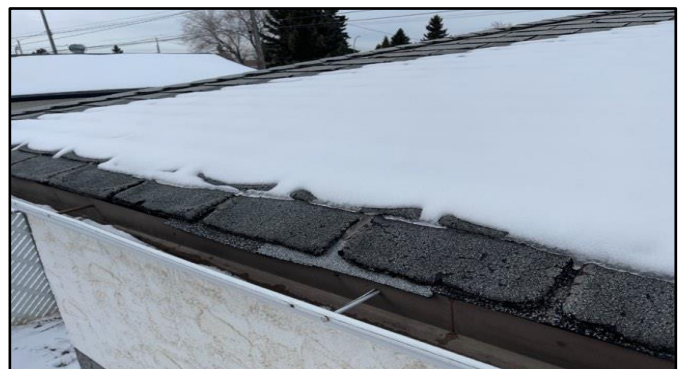
### Old, worn out

**Notes:** Garage roof shingles are near end of life. Recommend replacement.

**Implications:** Chance of water damage to structure, finishes and contents

**Task:** Replace

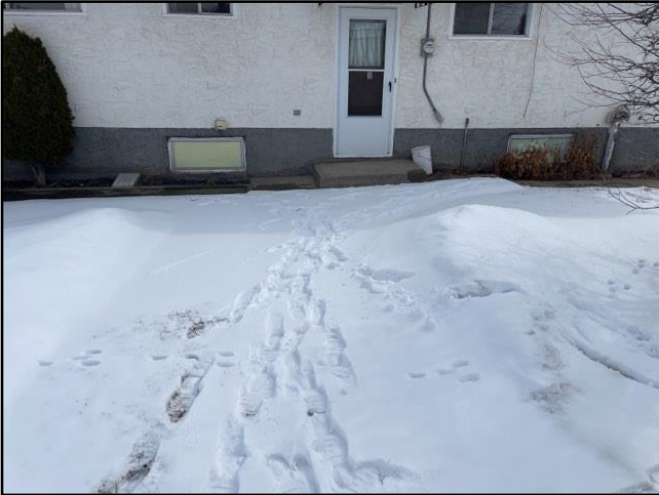
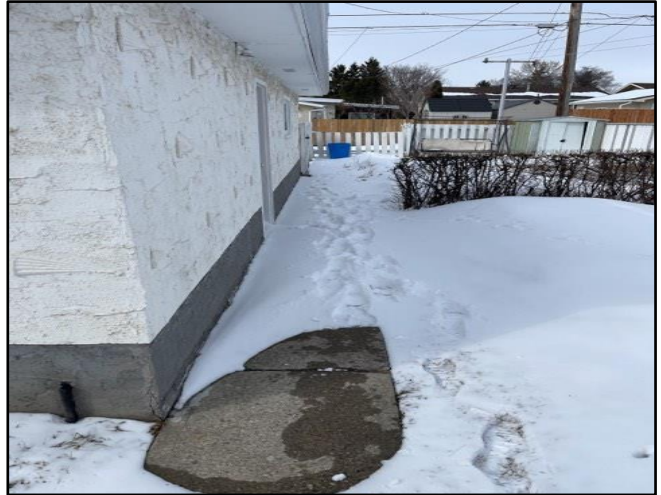
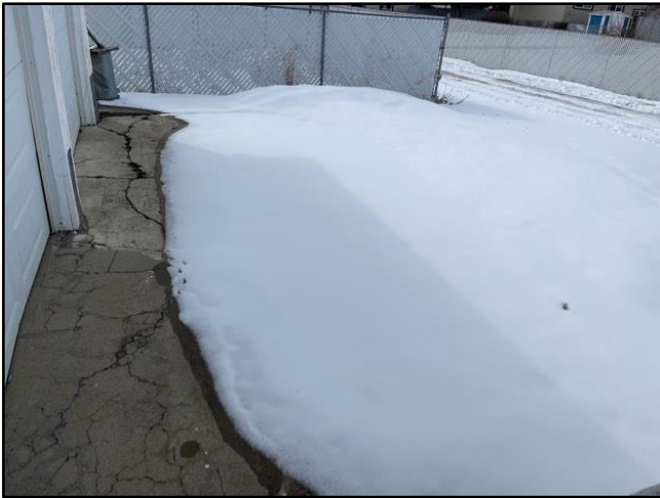
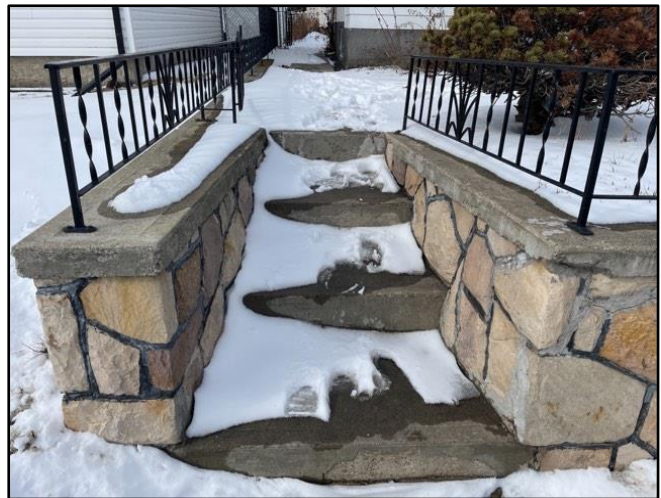
### Inspection limited/prevented by

Snow / ice / frost

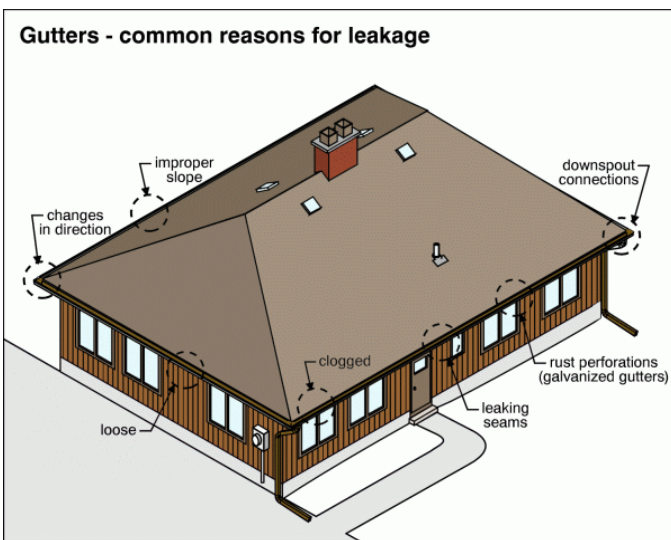
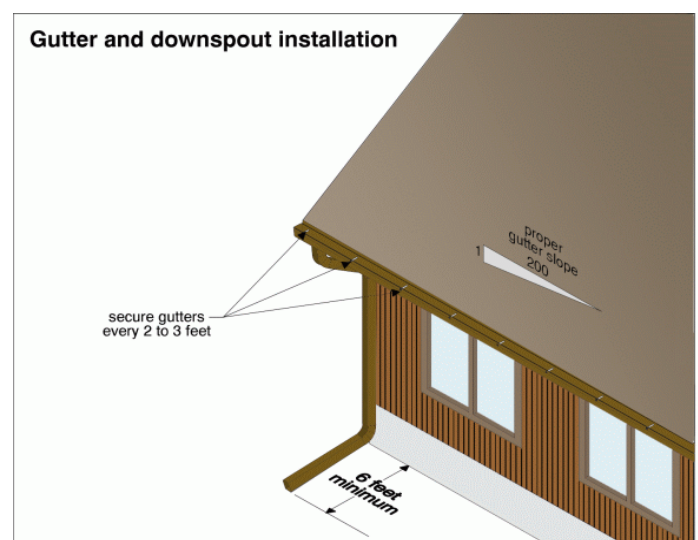
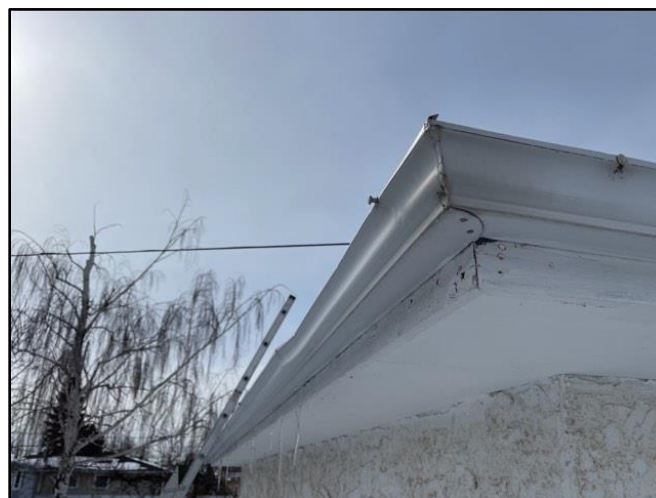
[Improper slope, ponding](#)

**Notes:** Gutters at garage are full of water. Recommend repair to avoid water infiltration.

**Implications:** Chance of water damage to structure, finishes and contents

**Task:** Repair or replace

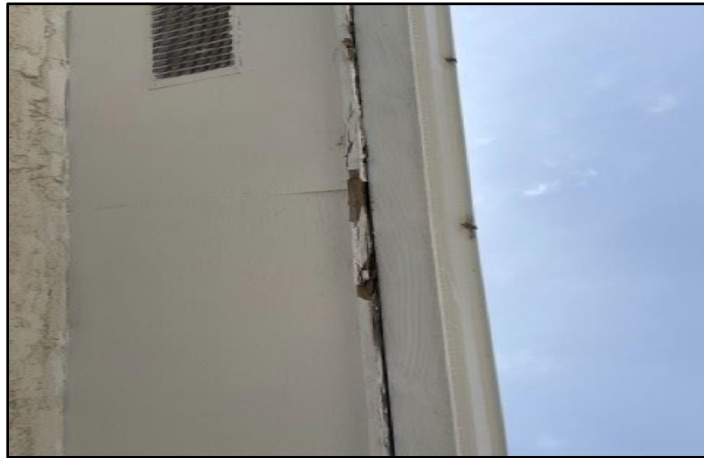
**Walls\Soffits (underside of eaves) and fascia (front edge of eaves)****Rot****Notes:** Facia under gutters showing signs of rot on north end of home. Recommend replacement.**Implications:** Weakened structure**Location:** North**Task:** Replace**Time:** Immediate

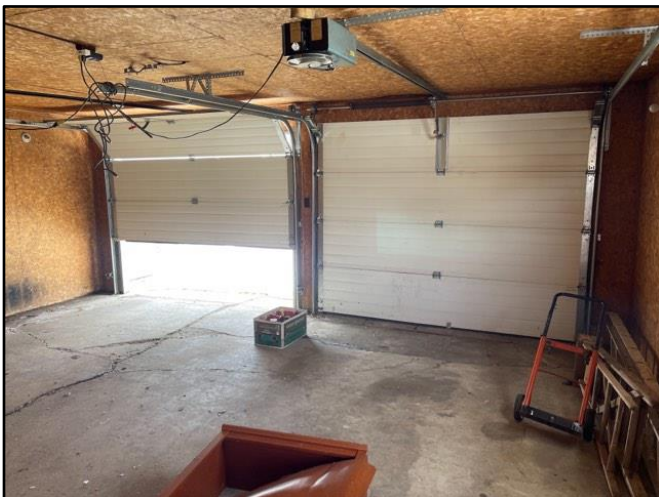
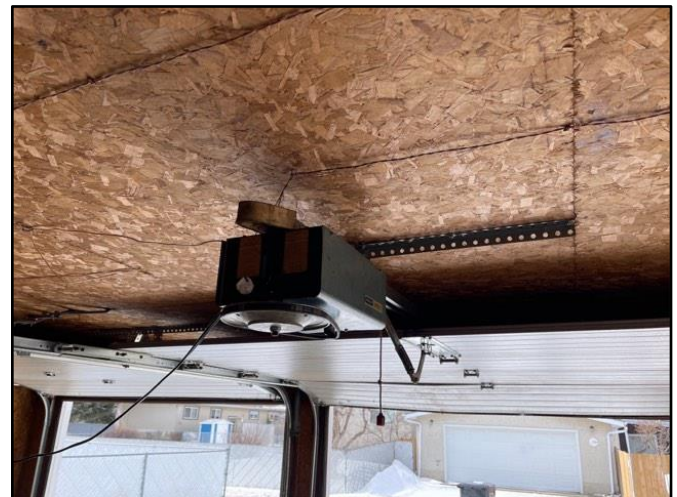
**Garage\Vehicle door operators (openers)****Sensors on north door of garage not present. Garage door opener at north door nearing end of its life. Recommend replacing with new unit including door sensors.****Location:** North**Task:** Replace**Time:** As soon as practical

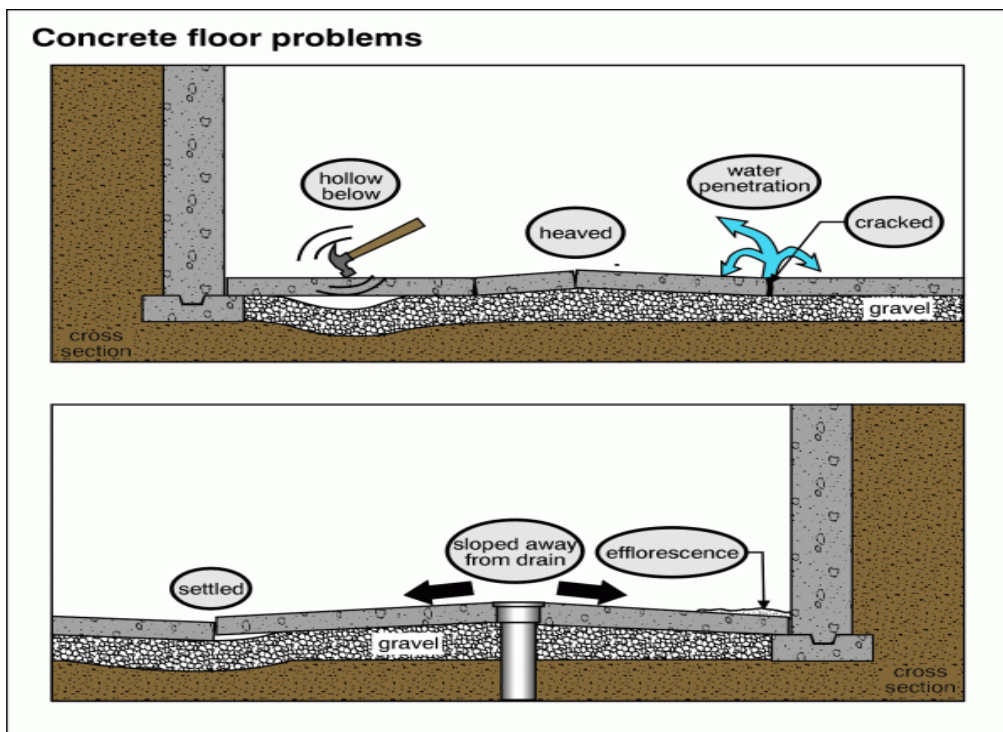
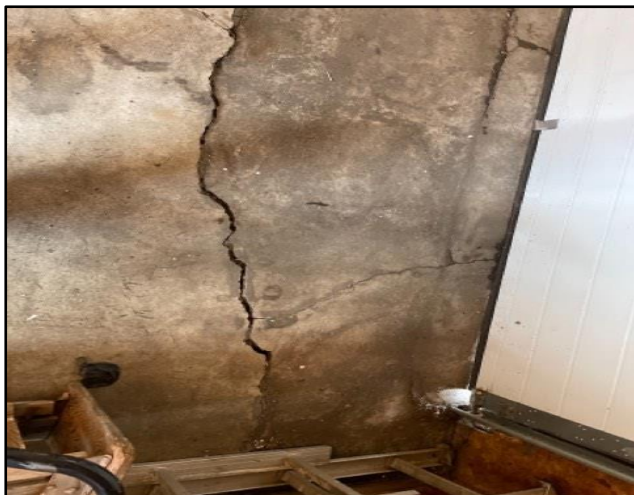
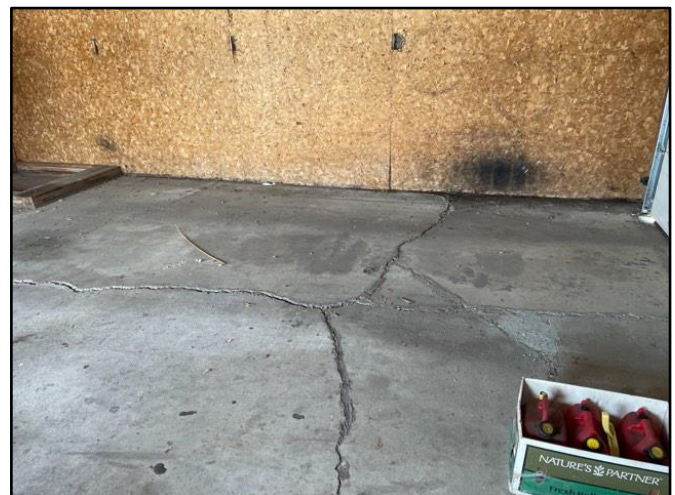
#### Cracked

**Notes:** Cracks in concrete floors is typical.monitoring is required for any separation of the cracks.

**Implications:** Trip or fall hazard | Chance of water damage to structure, finishes and contents

**Task:** Monitor

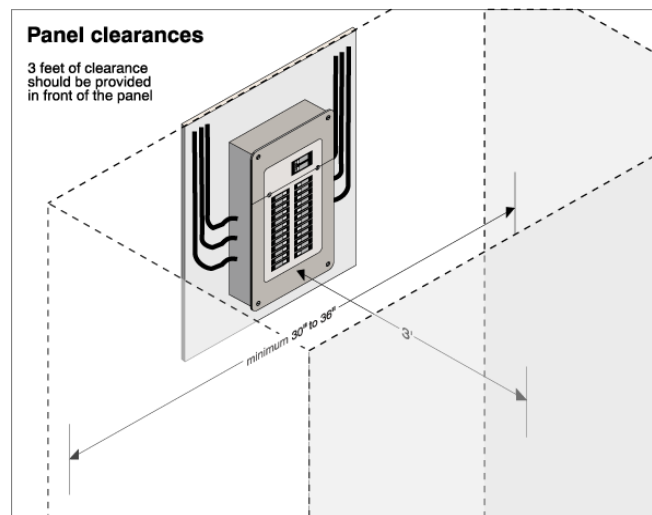
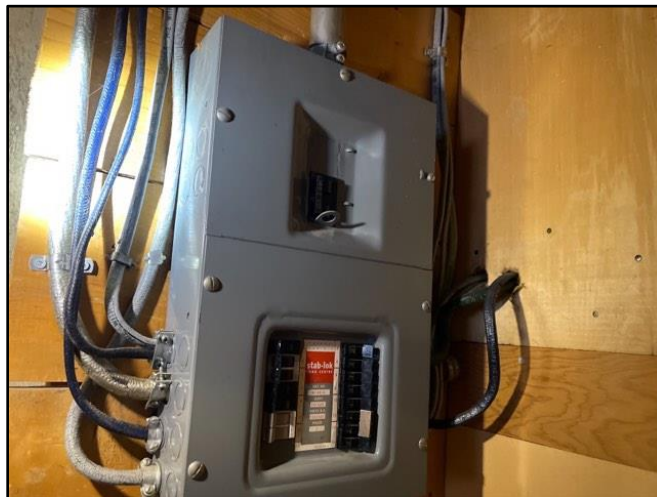
#### [Box location poor](#)

**Notes:** Service panel is located in small closet. Insufficient clearance in front of panel. Further evaluation by Licensed electrician required.

**Implications:** Difficult to service | Difficult access

**Task:** Correct

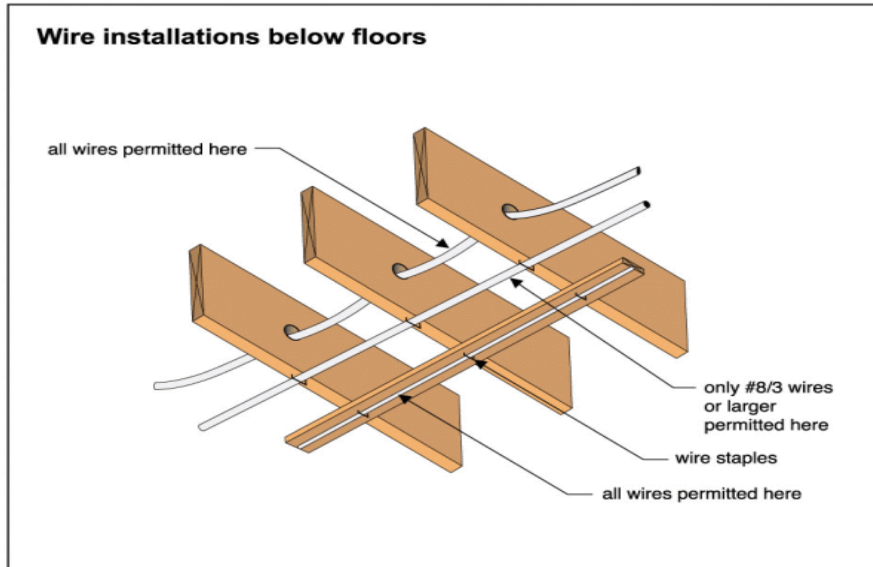
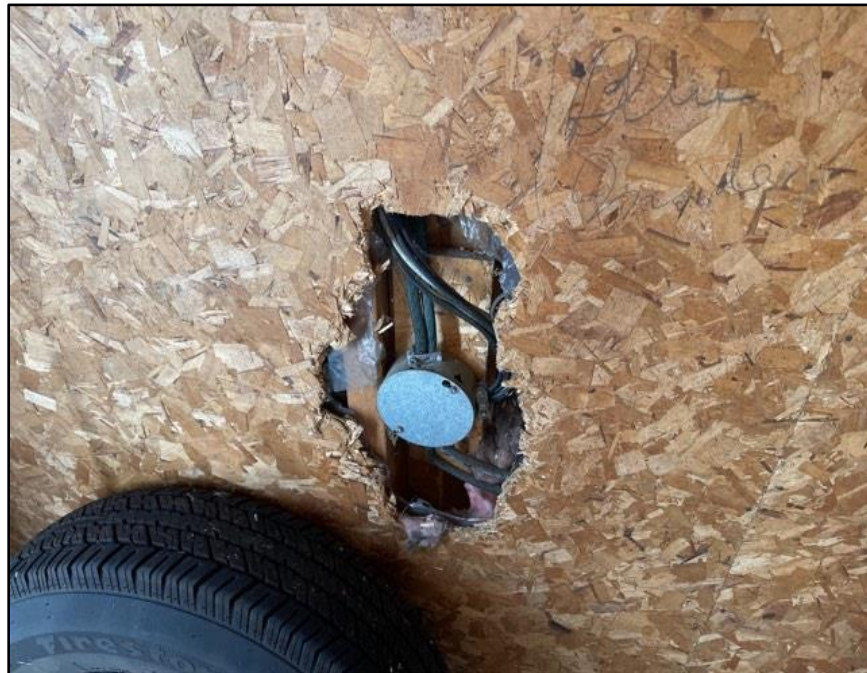
### Distribution system\Wiring (wires) - damaged or exposed

[Exposed on walls or ceilings](#)

**Implications:** Electric shock

**Task:** Correct

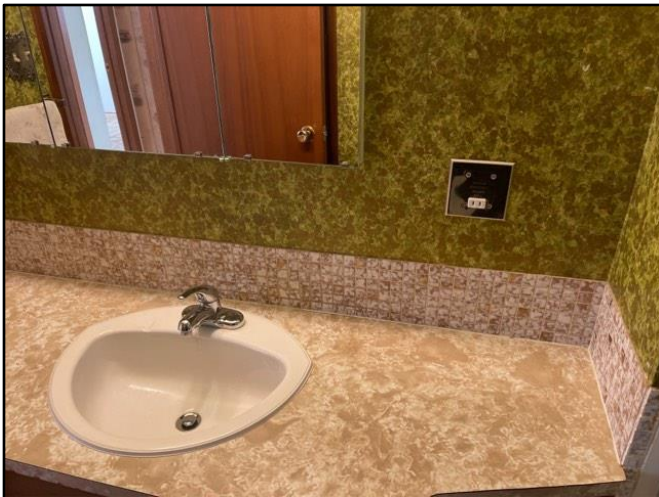
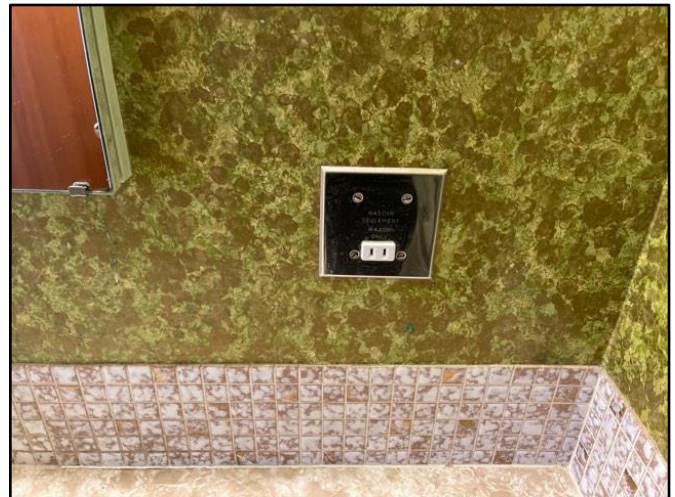
**Distribution system\GFCI (Ground Fault Circuit Interrupter) protection not noted at**

Bathroom

**Notes:** Receptacle at bathroom counter required to be GFCI protected as it is near sink location.

**Task:** Correct

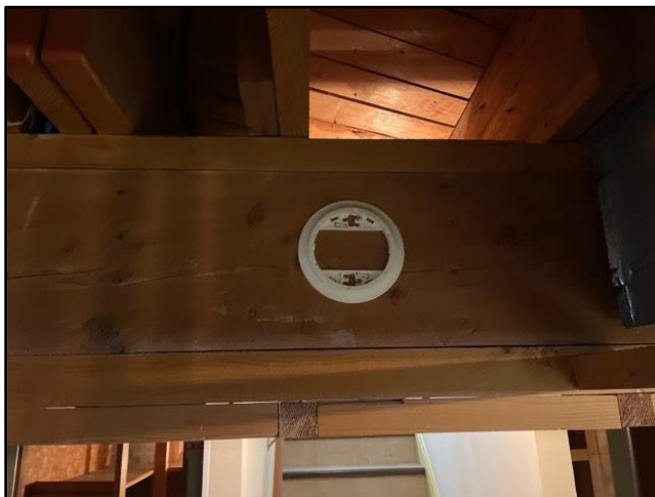
**Distribution system\Smoke alarms (detectors)**

Missing

**Implications:** Safety issue**Location:** Basement, hallway**Task:** Correct**Time:** Immediate

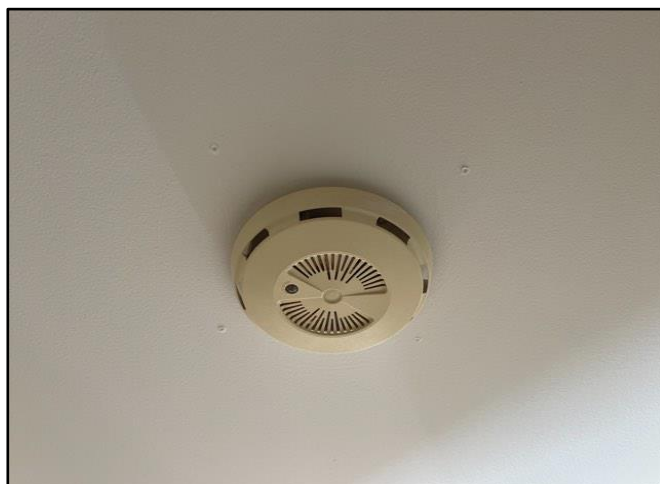
Past life expectancy

**Notes:** Recommend replacing smoke alarm with combination smoke alarm CO2 detector.**Implications:** Life safety hazard**Location:** Hallway**Task:** Replace**Time:** Immediate

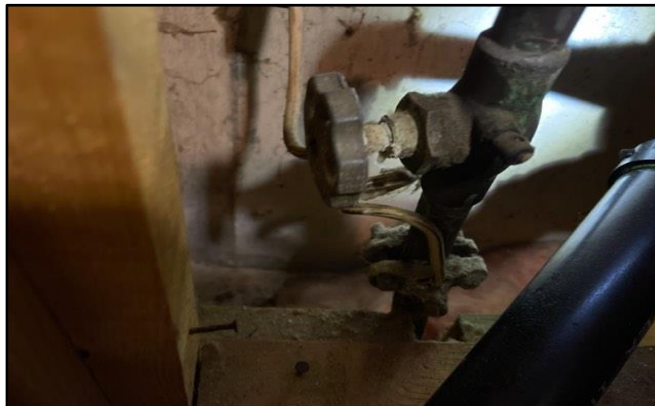
**Recommendations/Observations****Supply plumbingWater shut off valve**

Main water shut off showing signs of corrosion due to leaking. Recommendation is to monitor and replace as soon as practical

**Location:** North Basement Utility Room**Task:** Monitor**Time:** Ongoing

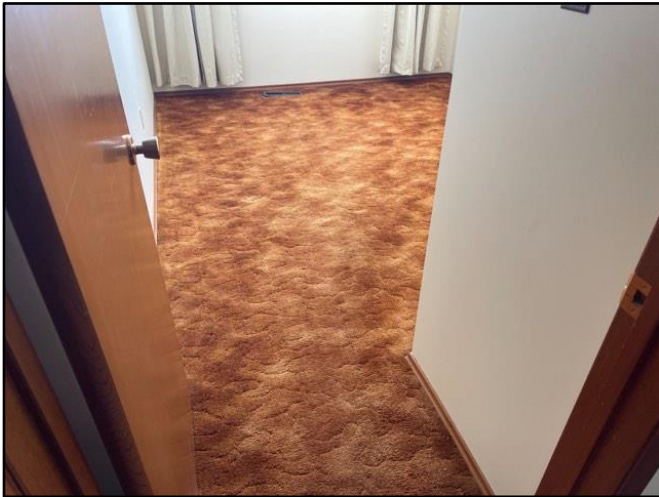
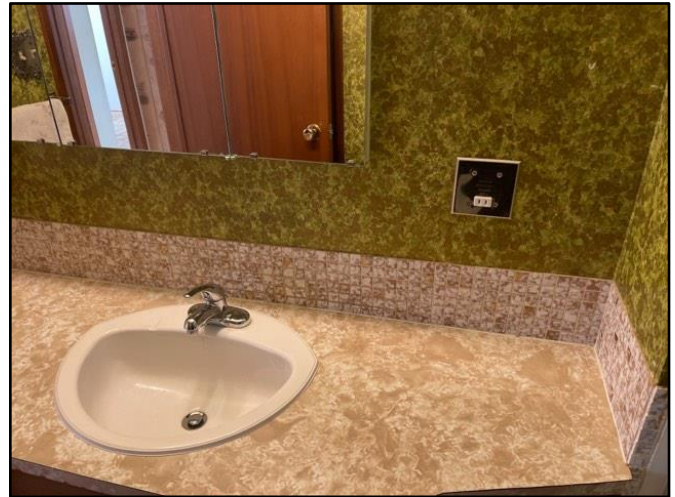
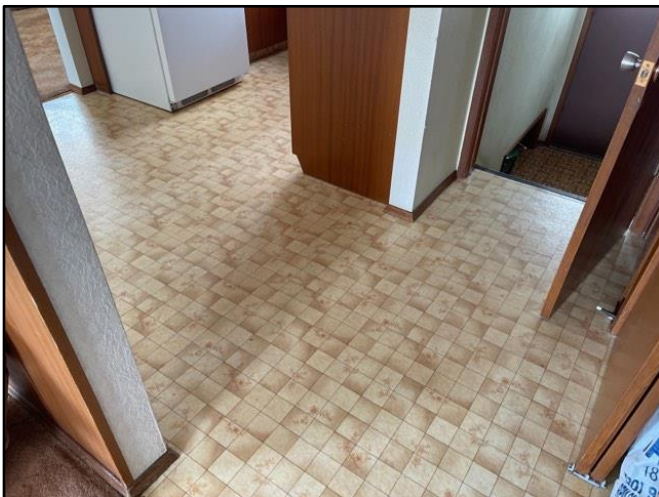
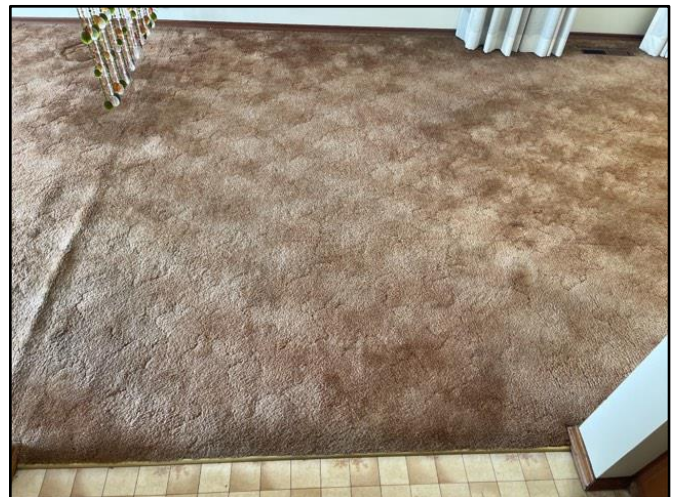
All interior components appear to be aging, this includes Flooring, wall finishes, and appliances. All components are in acceptable, usable, and operable condition but recommend ongoing monitoring.

**Task:** Remodel
