Your Inspection Report

129 Avenue St, Suite 1003
Chicago, IL 60622

RE: Report No. 10101, v.2
129 Avenue St, 1003
Chicago, IL
60622

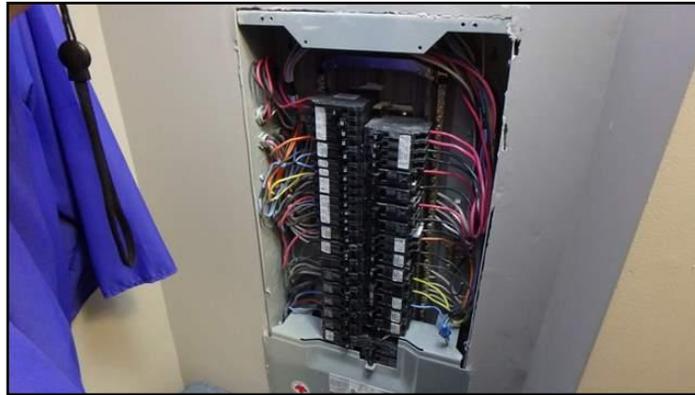
Distribution panel type and location:

• [Breakers](#)

Located in master bedroom closet.

Breaker Panel With Cover Removed

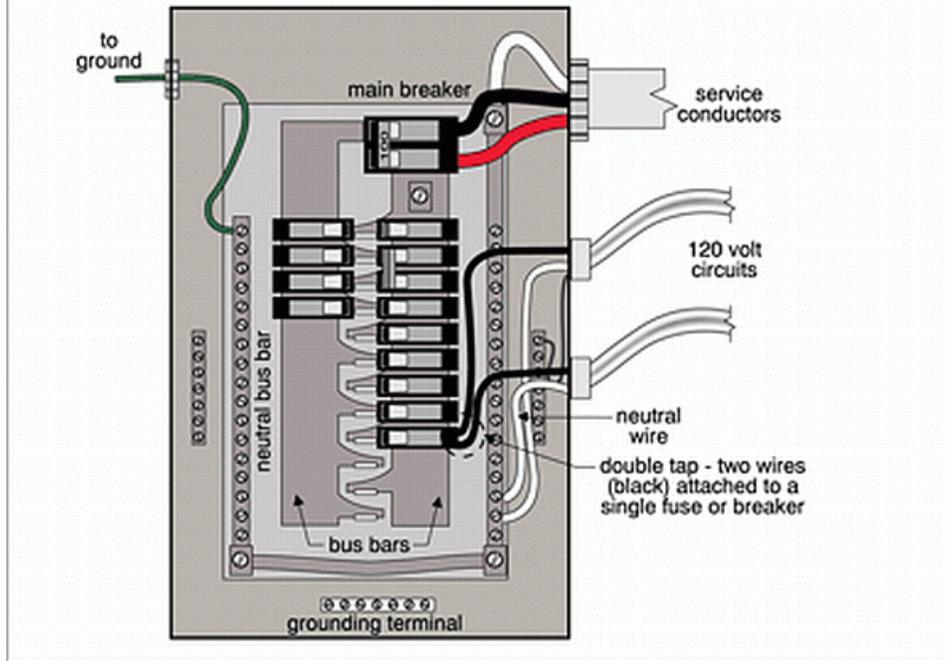
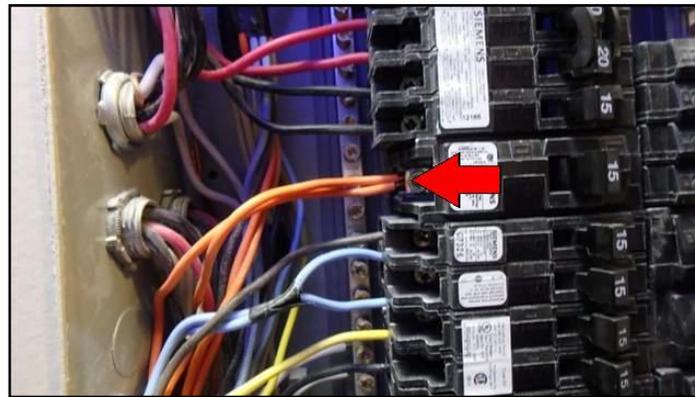
Condition: • [Double taps](#)

Two wires connected to a single breaker:

Double tapping (double lugging)

Double tap

Task: Monitor / Improve

Time: As soon as practical

Cost: Minor

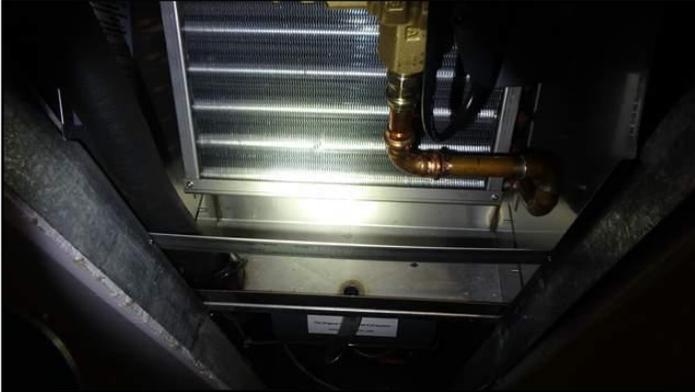
Note: Two 2-pipe fan/coil systems are used to heat and cool the unit. Each is controlled by its own thermostat. The interior components (coils, fans, condensate trays, piping, valves, etc.) appear to have been recently updated and both systems were working well at time of inspection.

New components

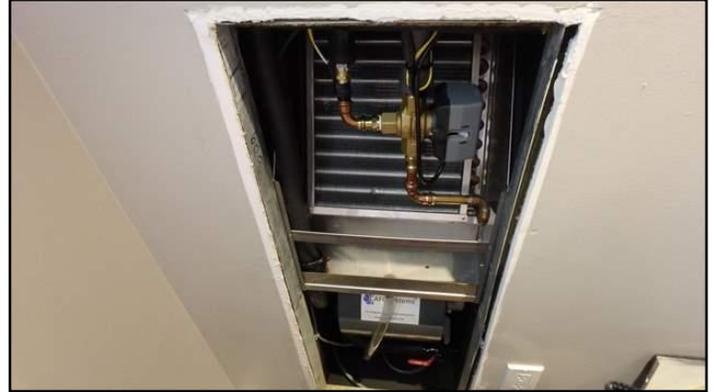
Fan/Coil Unit (Master Bedroom)

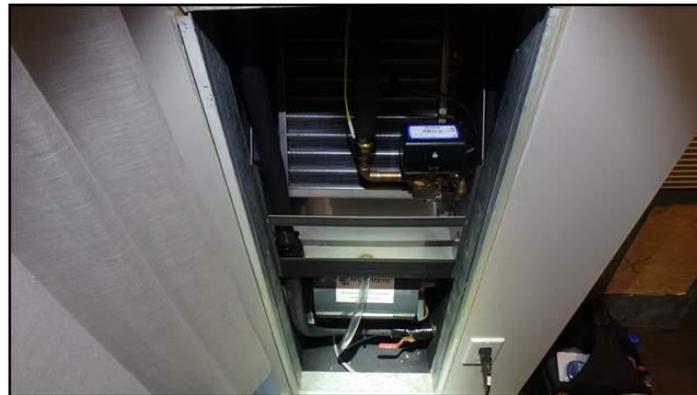
Fan/Coil Unit (Main living space)

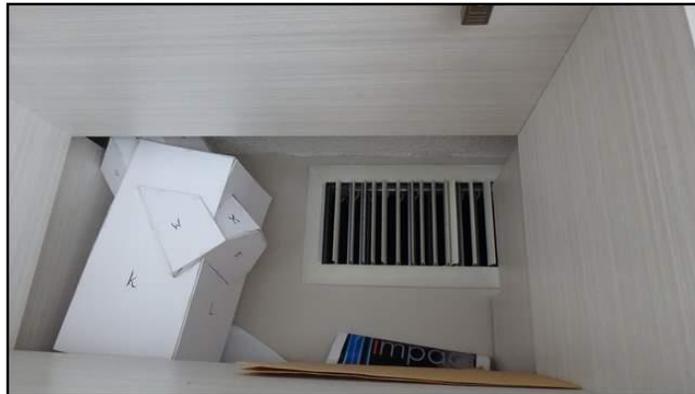
Condition: • Supply register in corner bedroom is set back in cabinet. This can reduce airflow and the overall ability to heat and cool the space.

Register in cabinet

Task: Monitor

Time: Ongoing

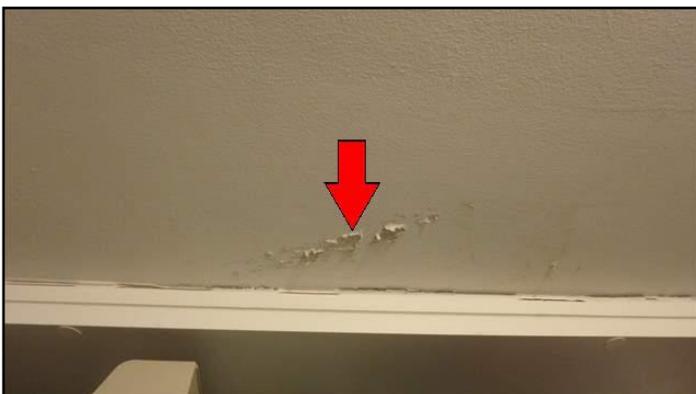
Ex. Patch on master bedroom wall, paint chips on window frames and around pot lights, gaps in flooring outside main bathroom, peeling paint on laundry room ceiling. Ensure moisture levels are monitored in laundry area (and throughout the unit). Keeping the laundry room door ajar is one way of improving airflow.

Ex. Peeling paint

Task: Monitor/Improve

Time: Discretionary/As required

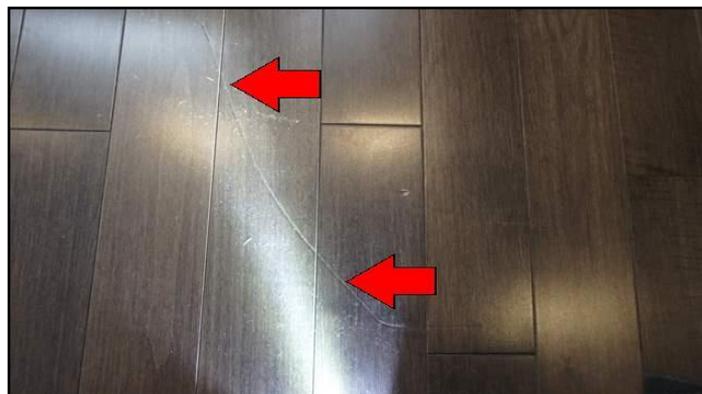
• Typical minor flaws were noted on floors, walls and ceilings. These cosmetic issues reflect normal wear and tear.

Ex. Typical wear on floors throughout

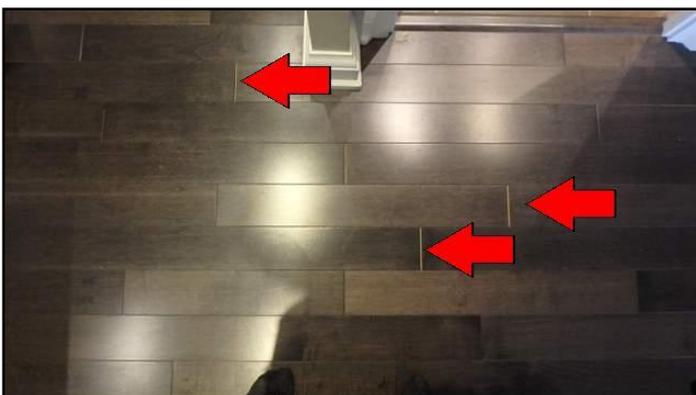
Ex. Gaps in flooring

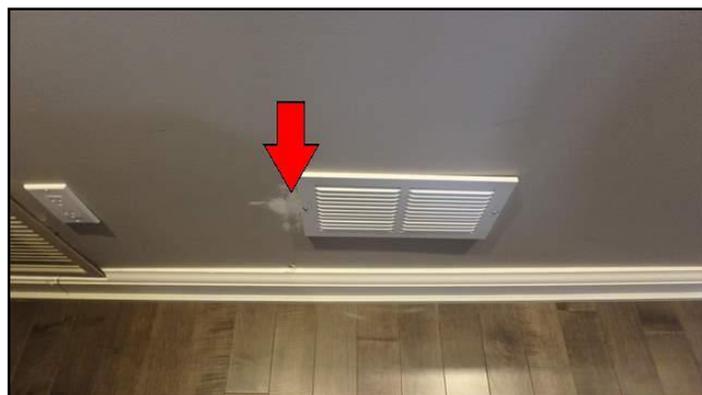
Ex. Patch

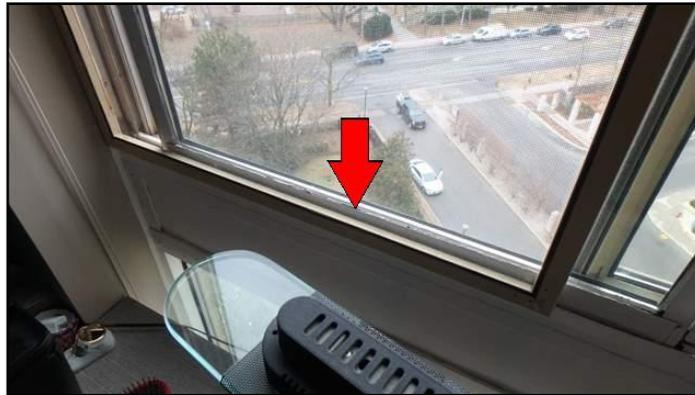
Condition: • Screen not installed in master bedroom. The other screens have been installed in an unconventional manner. Although non-standard, this appears to function as it should.

Ex. Non-standard installation

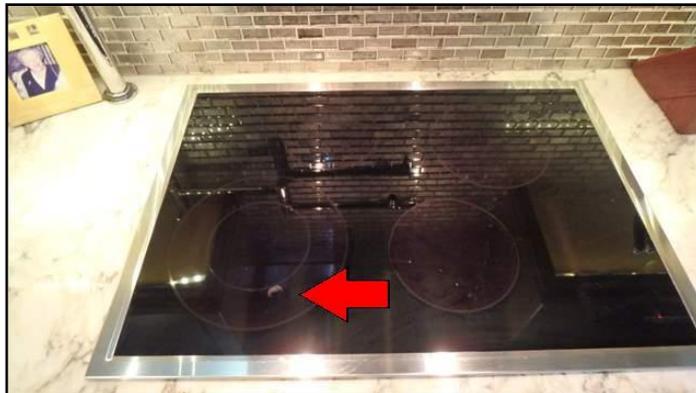
Condition: • Typical wear and tear on cooktop.

Ex. Typical wear

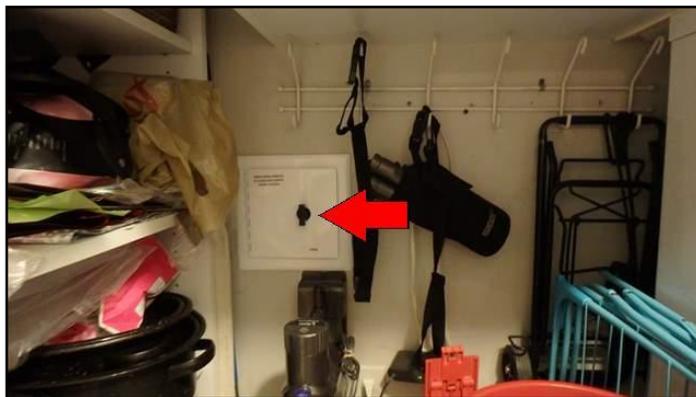
Condition: • Auxiliary dryer lint trap (located in ceiling above dryer) must be cleaned every 3 loads or more often as required.

Duct will likely need to be cleaned as part of routine maintenance.

Auxiliary dryer lint trap (located in...

Task: Clean

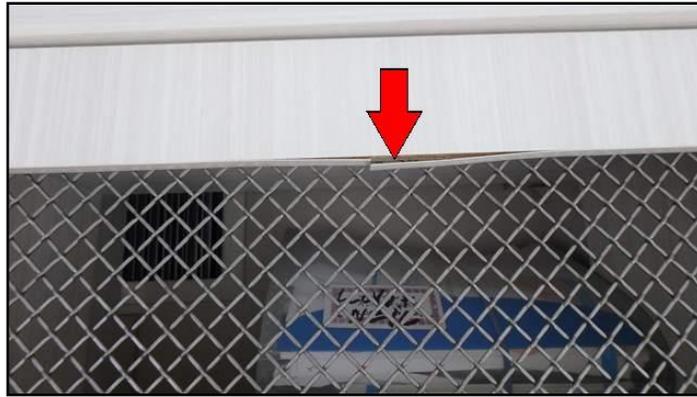
Condition: • Loose veneer noted

Location: Vent above bed in corner bedroom

Ex. Loose finishes

Task: Repair
